Appendix iv: Photos of sites suggested for improvement

Selsey ditch condition assessment results and habitat improvement plan

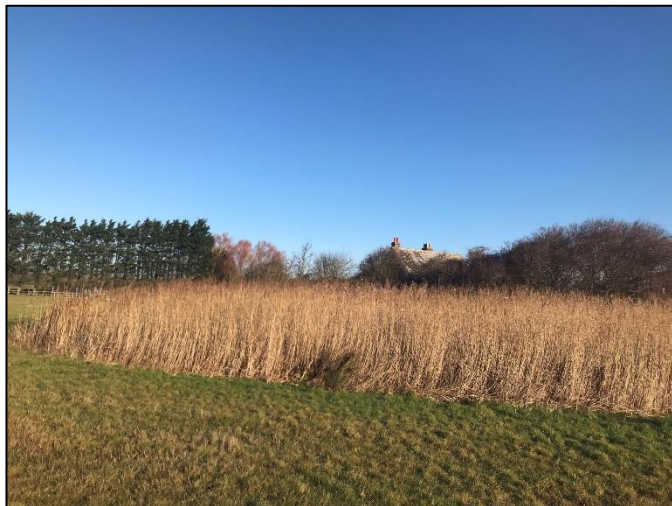
Ferry Corner pond – this relic pond is slowly becoming shallowed out with reeds and while it currently does not have dominating willow is at risk of disappearing. Light management with rotational willow cutting and a small section dug out to create some open water would be of benefit to many species. A water vole survey should be carried out as historically this pond has records for them and the appropriate mitigation and licenses need to be sought before work is carried out.

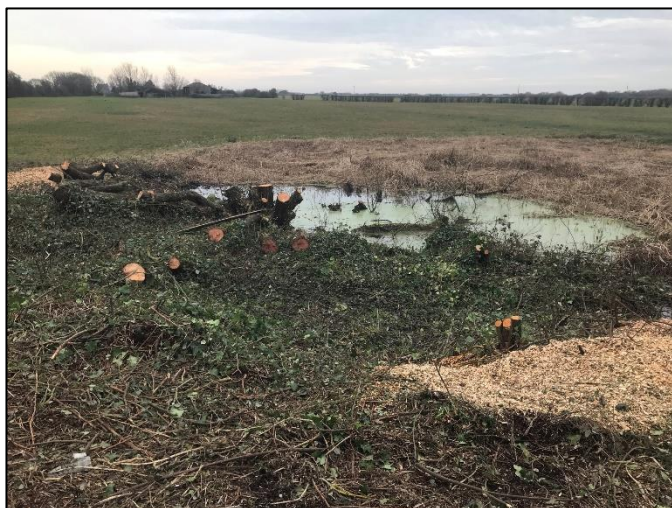
This pond was damaged at the end of February 2021 with complete reed flailing, despite being protected habitat, and the removal of the protecting hedge to the back. This pond will now need to recover to offer habitat for water voles and tree planting will need to take place to reinstate the line of hedgerow.

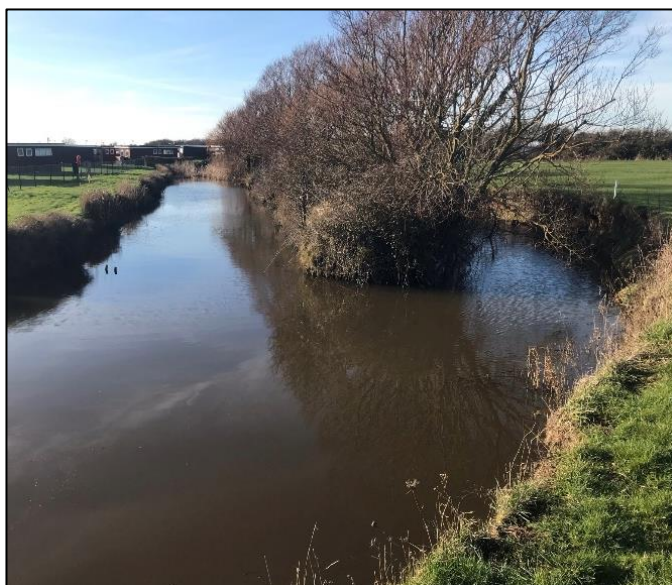
Selsey Golf Course pond 1 – this pond has huge wildlife value as it stays wet year through and is connected to the wider wetland system via ditches. There is a steep natural earth wall to the north and this could have potential for kingfishers to nest. Currently the pond has little in channel and riparian vegetation and the banks are mowed to the edge leaving them very exposed. This can contribute to erosion as well as reducing the wildlife potential. Less mowing will be more cost effective and the pond could become an attractive feature for people and wildlife.

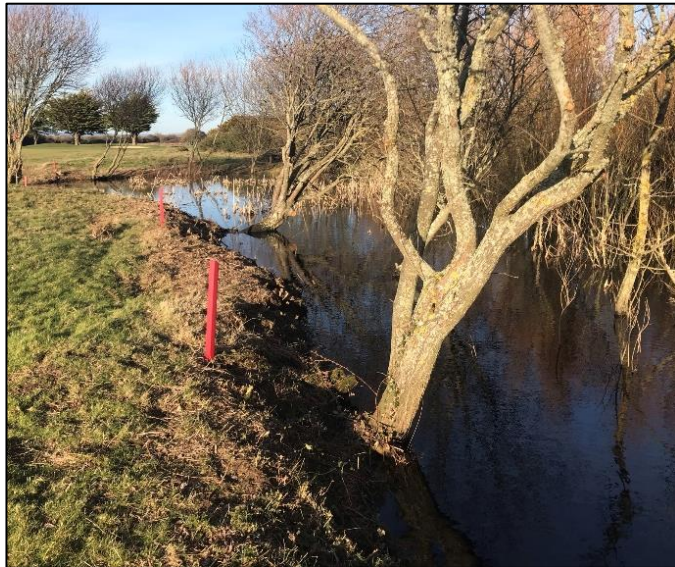
Selsey Gold Course pond 2 – this pond is valuable as it borders the edge of the golf course and is joined by ditches and a thick hedge. It is currently mowed to the edge and there is no evidence of bankside vegetation which contributes to erosion. By managing the willow trees to reduce the shading, adding riparian plants, and leaving a 2-5 metre border of unmown vegetation on the periphery of the pond, it would offer more habitat opportunities for wildlife. Less mowing will be more cost effective and the pond could become an attractive feature for people and wildlife.

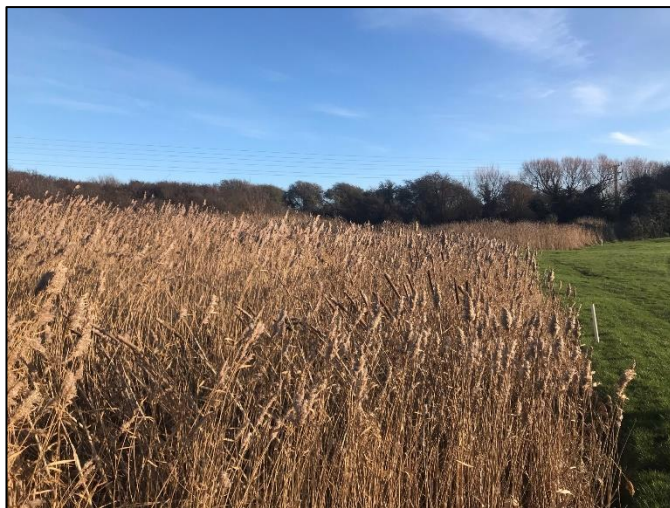
Selsey Golf course reedbeds – these reedbeds are of huge wildlife value and the fact that they are bordered by a dense hedge and scrub area will offer habitat to a large range of birds, mammals, and invertebrates. These reedbeds may benefit from a rotational cut and a small section opened up to create a small section of open water. The edge of the reedbeds is currently mowed to short grass and a buffer along this periphery off vegetation allowed to grow longer would be of huge benefit, while also being more cost effective.

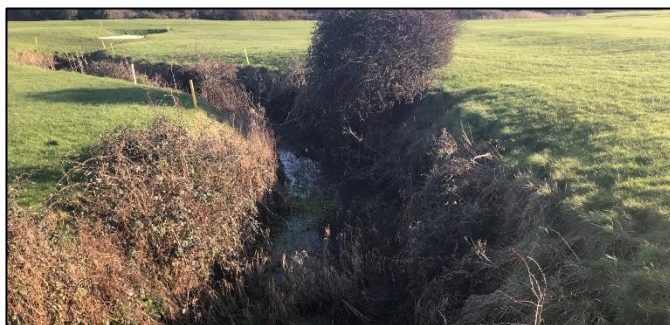
Selsey Golf course ditches – these ditches dry out in the summer months but will still offer good habitat for many species. Allowing a buffer zone along the edge of the bank that is not so tightly mown or strimmed would prevent erosion and offer a greater variety of habitat opportunities for invertebrates, reptiles, and birds. It may also prevent the loss of golf balls into the water channel and litter blowing into the channel.

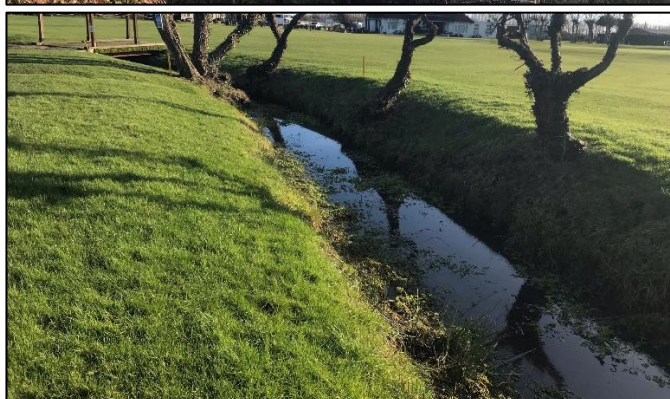
Less mowing will be more cost effective and the pond could become an attractive feature for people and wildlife.

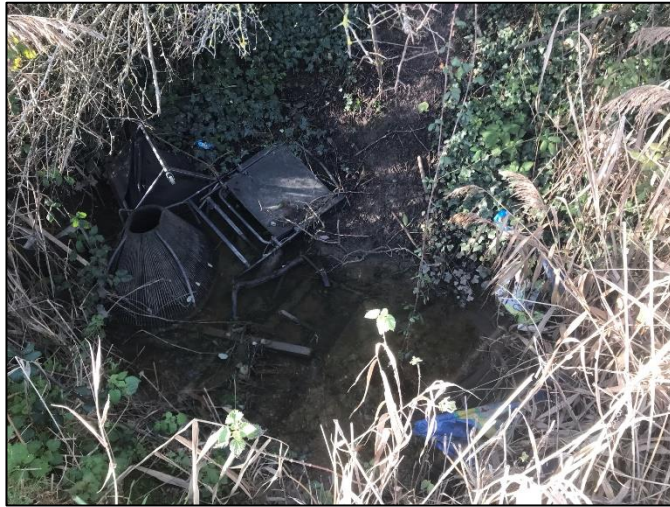
Selsey Golf Course periphery ditch

– this ditch is important as it is large and stays wet year-round. It is bordered to the west by a mature hedge and this add wildlife value to this waterway. Unfortunately, it is also quite shaded and is tented in places by bramble that could be managed back to expose the water. The ditch is also quite full of rubbish in places and this could be as a result of the wind action across the site. This needs to be removed and managed as it will affect water quality as well as biodiversity.

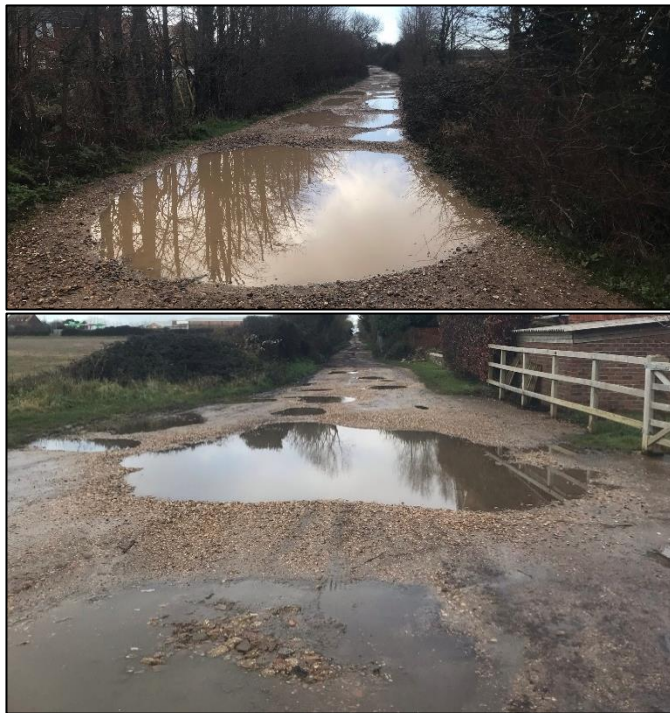
Park Lane ditches

– this private unmade lane is very prone to flooding and was probably once bordered on both sides by ditches that carried the surface water away and not the drainage system, now culverted, that links with East Beach pond. Over time with different developments, filling in, and neglect, the continuity of these ditches has been interrupted and therefore the water no longer travels away. This results in the remaining, often shallowed out, ditches, acting like ponds that fill and then overtop as there is now where for the water to go. To solve this issue a combined approach involving all the landowners, digging out, joining up and connecting the ditches to a route for water to travel away will be necessary.

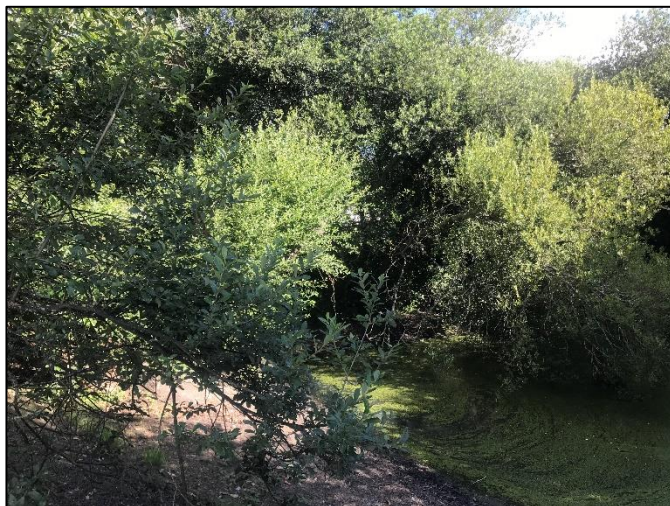
Bunn leisure – the Willows Pond

– This pond is a dark and shady but could be much improved and biodiversity increased with careful tree management, digging out the base and the introduction of wetland plants via coir rolls.

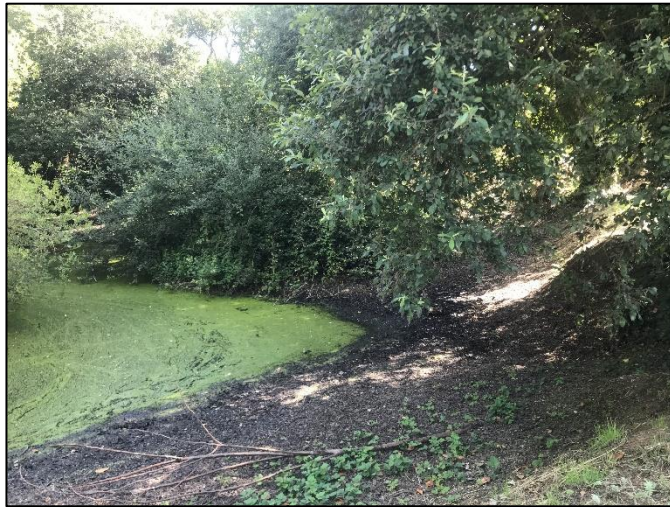
Bunn Leisure - Green Lawns pond

- This pond is a dark and shady but could be much improved and biodiversity increased with careful tree management, digging out the base and the introduction of wetland plants via coir rolls. The edge of the pond would benefit by allowing a buffer area to be established that is not mown and this would provide better habitat for invertebrates.

Less mowing will be more cost effective and the pond could become an attractive feature for people and wildlife.

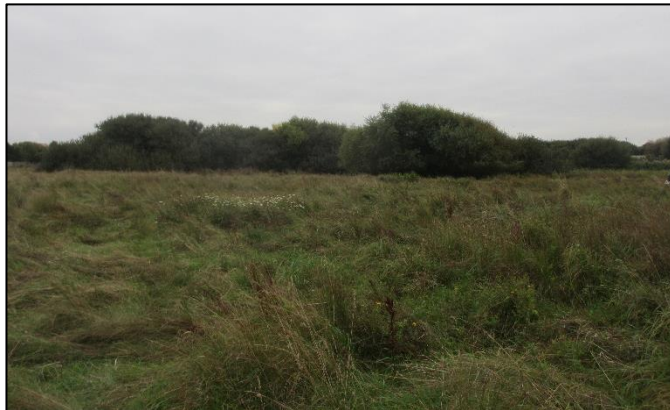
Crablands meadow –

the relic pond in this meadow is currently disappearing as willow has taken over and the pond is shallowing out and all open water lost. This pond would benefit from having the willow managed allowing light to get in on the water and a range of wetland plants to be established. The pond would also be improved with digging out as the willow has shallowed it and it is less likely to hold water year-round.
